DEPARTMENT OF TRANSPORTATION

Quality Assurance and Source Inspection

Contract #: 04-0120F4Cty: SF/ALA Rte: 80 PM: 13.2/13.9File #: 69.28**WELDING INSPECTION REPORT****Resident Engineer:**Pursell, Gary**Address:** 333 Burma Road**City:** Oakland, CA 94607**Report No:** WIR-012180**Date Inspected:** 03-Feb-2010**Project Name:** SAS Superstructure**OSM Arrival Time:** 645**Prime Contractor:** American Bridge/Fluor Enterprises, a JV**OSM Departure Time:** 1845**Contractor:** Zhenhua Port Machinery Company, Ltd (ZPMC), Changxing Island **Location:** Shanghai, China

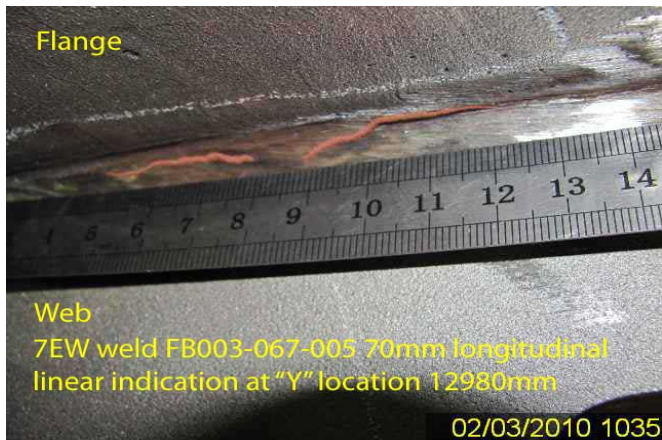
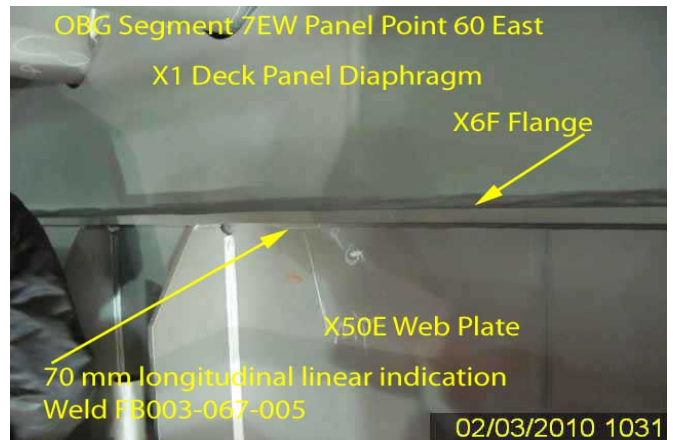
Caltrans Quality Assurance (QA) Inspectors performed random visual inspection of OBG segment 7EW upper section of the east side of panel point 60. During Visual Inspection 1 (one) Longitudinal Linear Indication (LLI) were found on OBG Segment 7EW Floor Beam FB3A web to flange weld, FB003-067-005 at "Y" Location

12980mm (LLI-70mm) at panel point 60 (east side). This indication was confirmed with MT by Caltrans QA. An incident report was issue for the above mentioned indications. For further detail see the attached photos below.
